# Northeast Gas Association

2020 Virtual Gas Operations School

# Incident Investigation for the First Responder

Brad Thomas

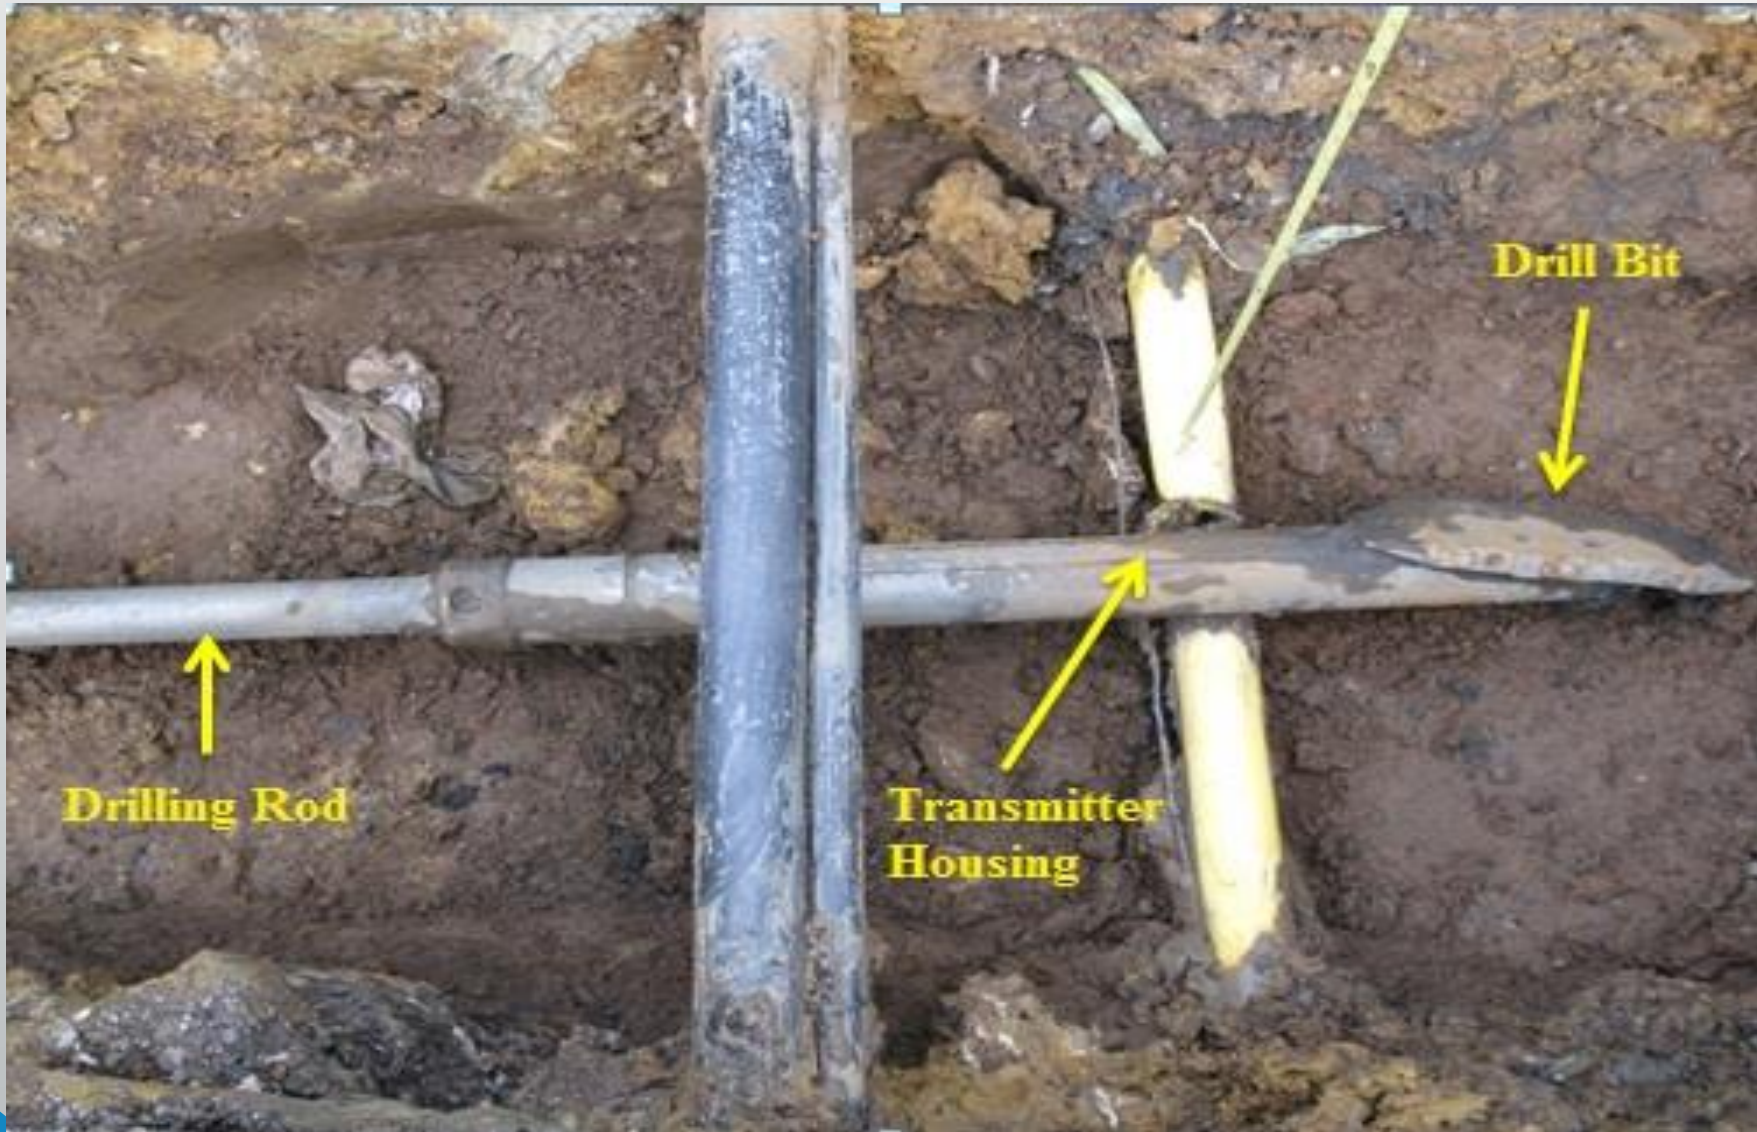
Site Drawing			
EXP/MGE/KANSAS CITY			
PROJECT NO.	FILE NAME		
B7948	SiteDrawing.dwg		
Inspection Date	VARIOUS	DR JT	PAGE 1 OF 1

- Gas company personnel and workers from two contractors were at the location of the damaged natural gas main at the time of the explosion.
- Several of these individuals received injuries as a result of the explosion and subsequent fire.
- The source of the gas that caused the explosion and fire was from a damaged 2" PE main operating at 25 psig.
- The cause of the damage was a horizontal drill being operated by a contractor installing a fibre optic line for the local phone company.

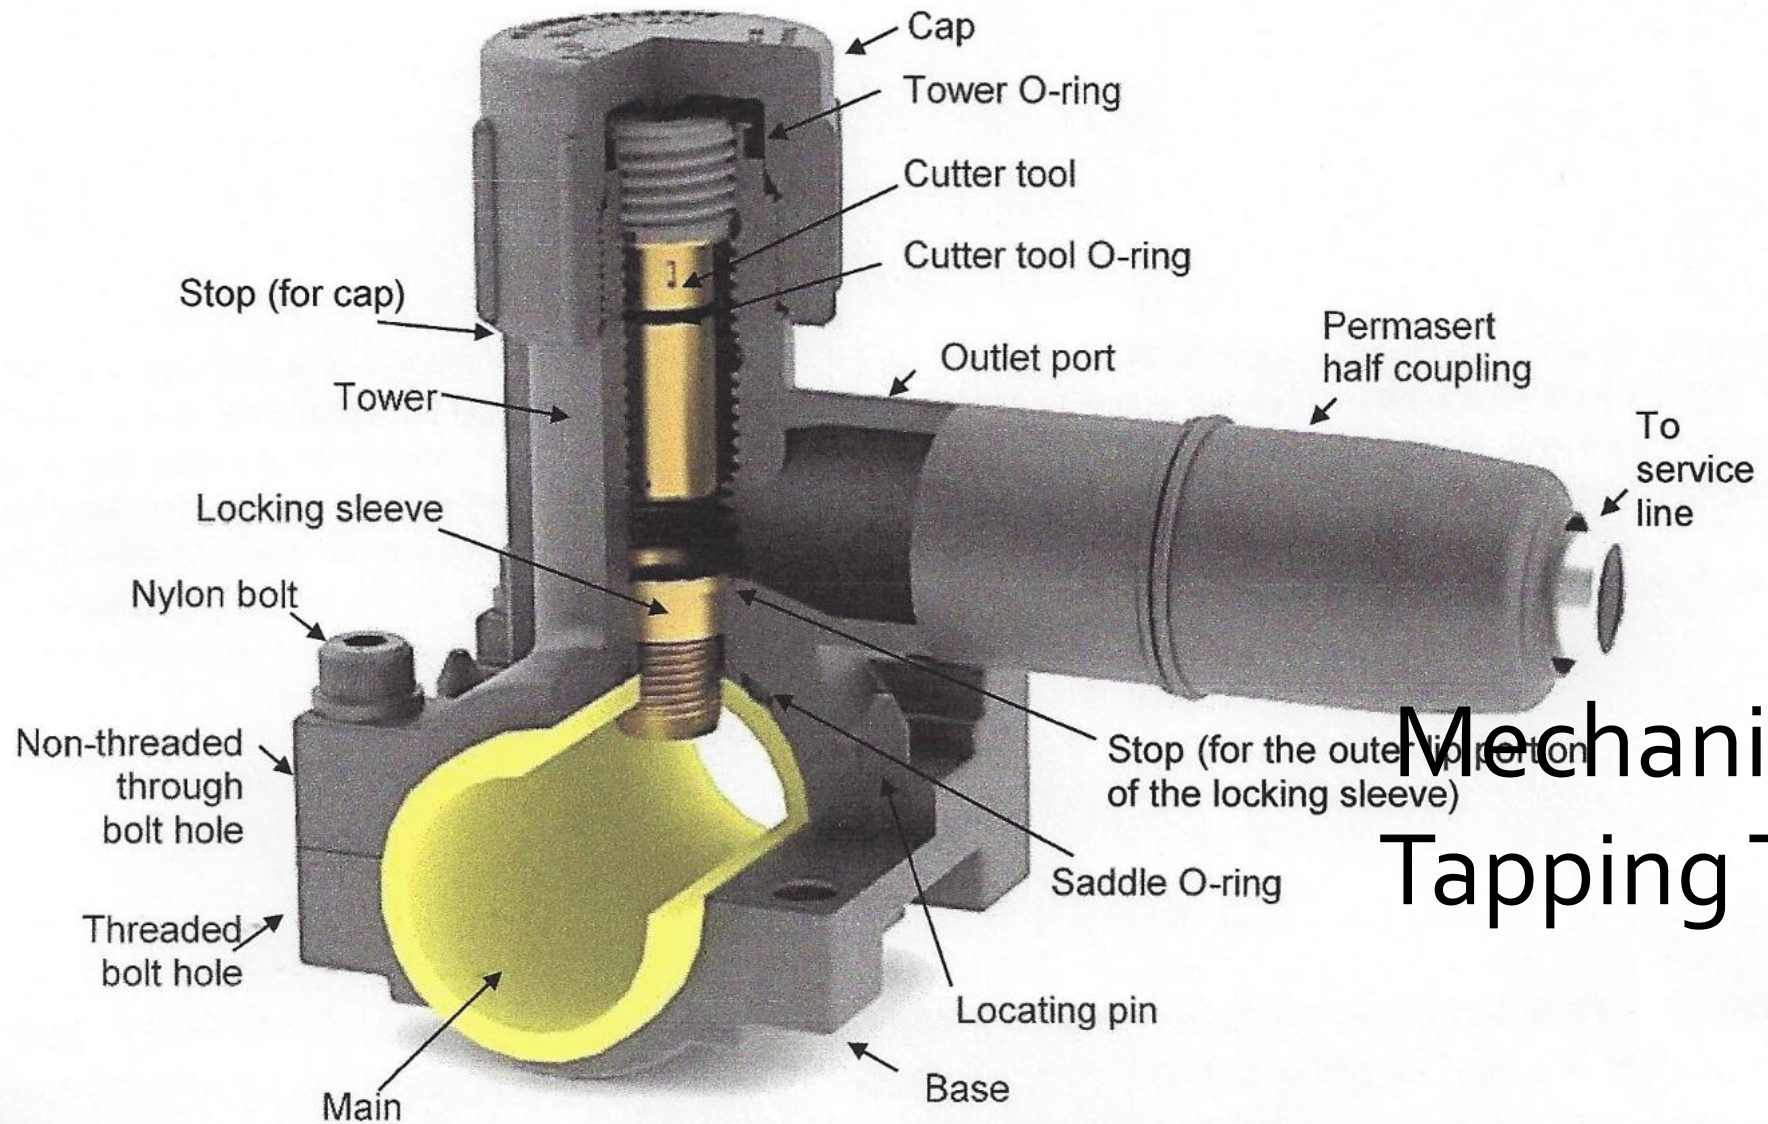
# Mechanical Tapping Tee

- The National Transportation Safety Board determines that the probable cause of the natural gas explosion at 206 Springdale Lane was in improperly installed mechanical tapping tee that leaked and allowed gas to migrate into the house where it ignited.

**Figure.** Cross-section diagram of an exemplar PermaLock mechanical tapping tee assembly, provided by Honeywell

- Pipeline Facility Improvements
  - Ongoing project to identify and repair or replace mechanical tees through the distribution system
  - As of October 2018, 2,577 mechanical tees have been remediated or replaced
- Dispatch Improvements
  - The operator modified their dispatch process or proactively identify the need for electrical shutdown and additional help
