Unlocking RD&D Potential: An Overview of NYSEARCH & Utility Pipeline Robotics Inspections

NGA Gas Operations School

Robotic MFL Inline Inspection

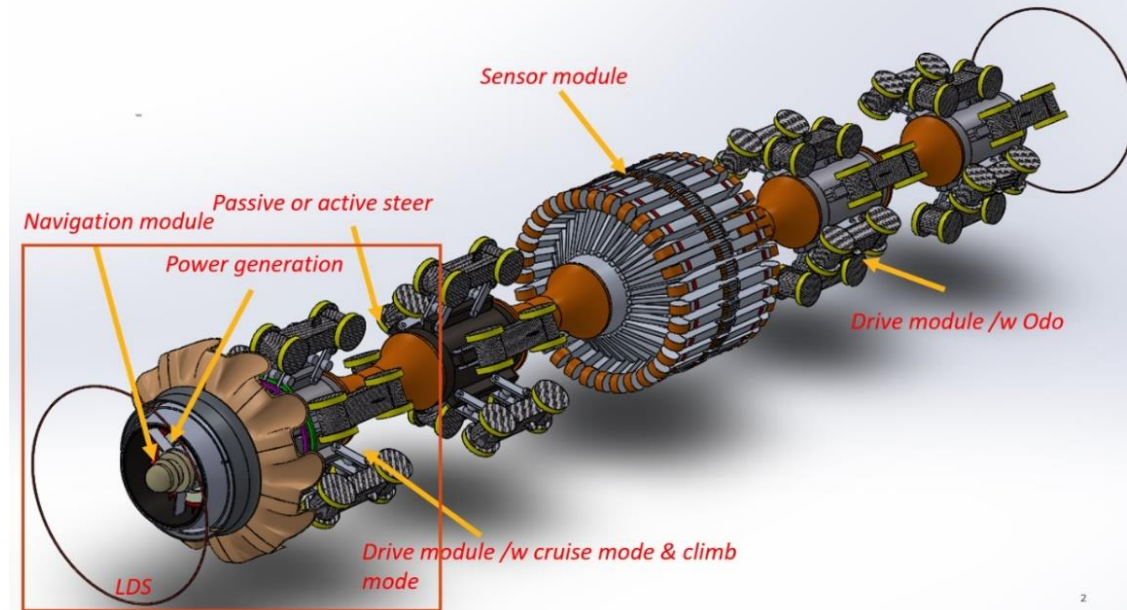
Concept Explorer Gen II

- Self-propelled autonomous robot for data collection of pipeline condition
- Pipelines with gas flow: Unlimited power and communication range
- Pipelines without flow: Range increase by 2X
- Revised platform with integrated sensor technologies: A-MFL, C-MFL, Geometry, Crack, IMU, navigation, environmental, etc.
- Latest technologies including battery/power mgmt (2024 vs 2008)
- Increased payload capability
- Variety of NDT technologies, delivering more & better data
- Automatic upload of data to cloud-based storage
- Advanced AI data analysis. Greater quantity and higher accuracy data collection

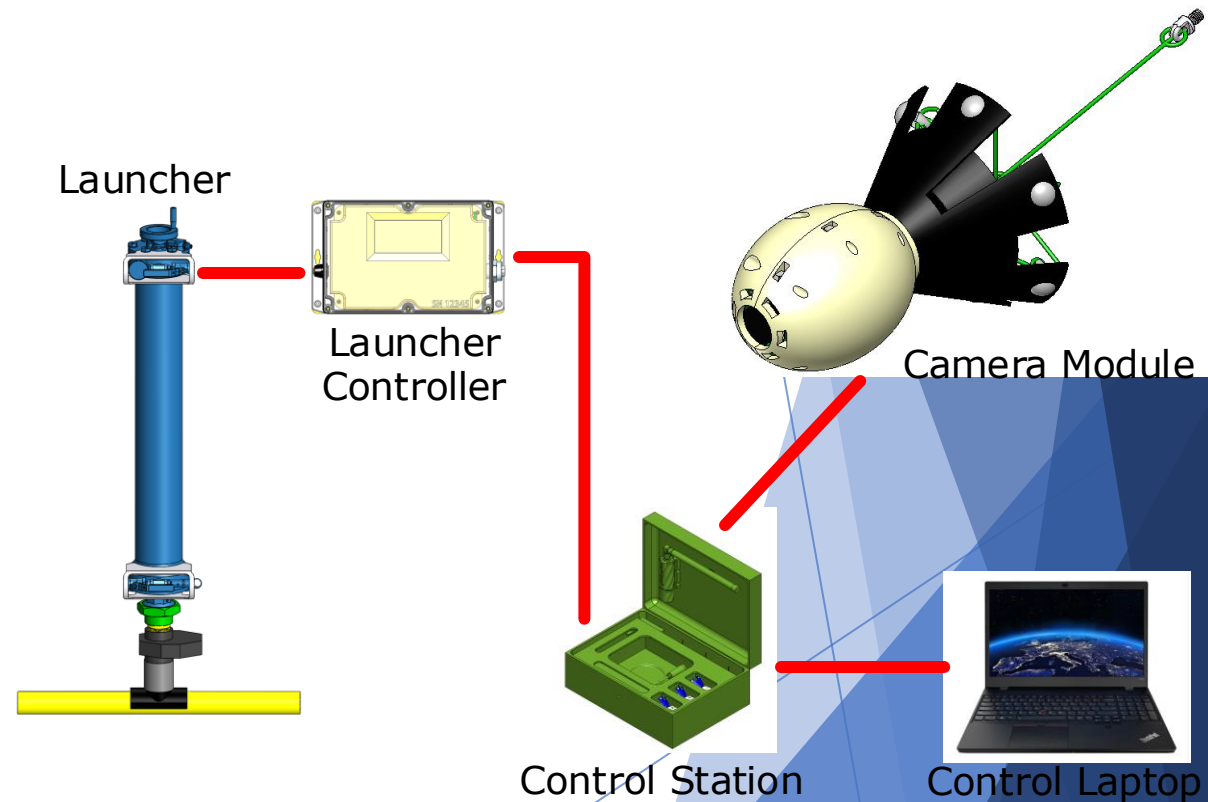
2 Inch Pipe Glider System - 2025 release

Current gas camera inspection systems can only inspect up to 200ft at a time. This means to inspect ~1000ft, at least 3 Bell Holes need to be constructed.

System Overview:

Camera Module: Camera system that traverses and records the pipe interior.

Launcher: Launches and receives the camera module inside the pipe.

Launcher Controller: Gives camera module telemetry feedback to the operator.

Control Station: Operation hub for setup.

Control Laptop: Data retrieval and video processing

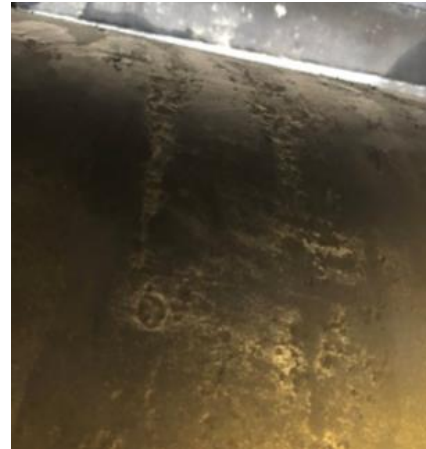
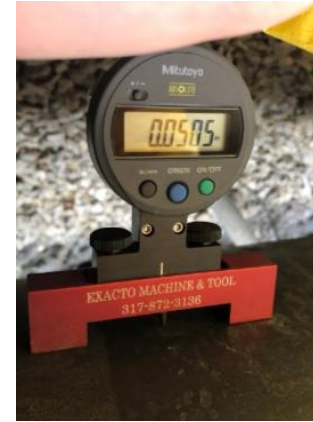
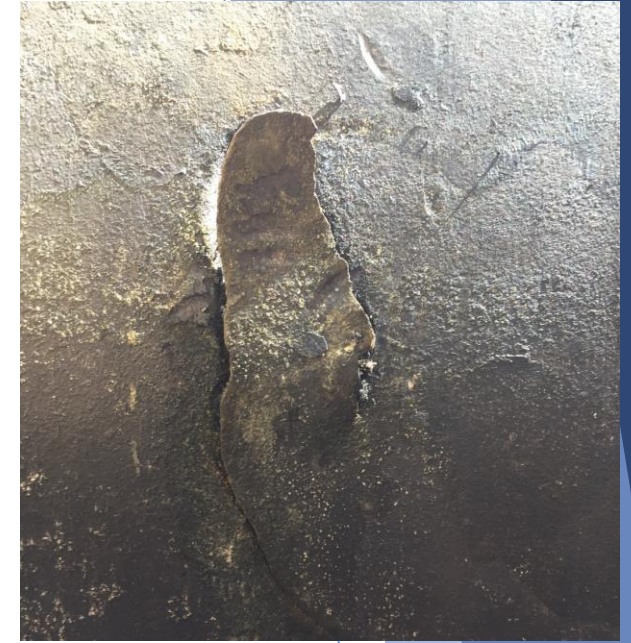
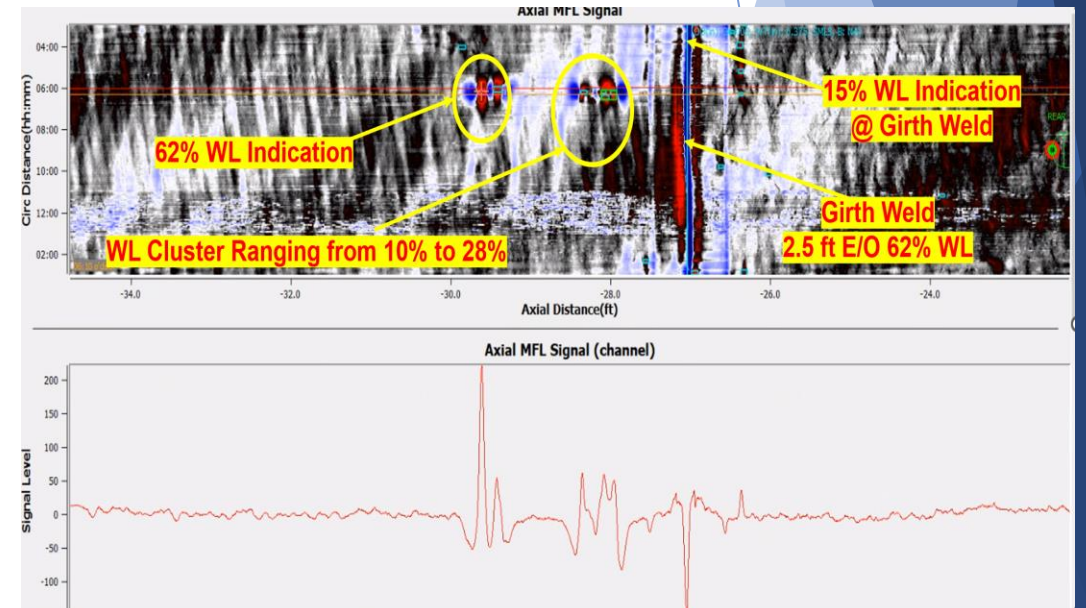
Types of Anomalies Found

- ▶ 25% wall loss due to corrosion
- ▶ Surface delamination up to 3"

- ▶ 62% wall loss
- ▶ Multiple clusters of 10-28% wall loss
- ▶ >60% wall loss at Girth Weld

- ▶ Areas of corrosion pitting
- ▶ Repaired with clockspring, wrapped with wax tape & rockshielding

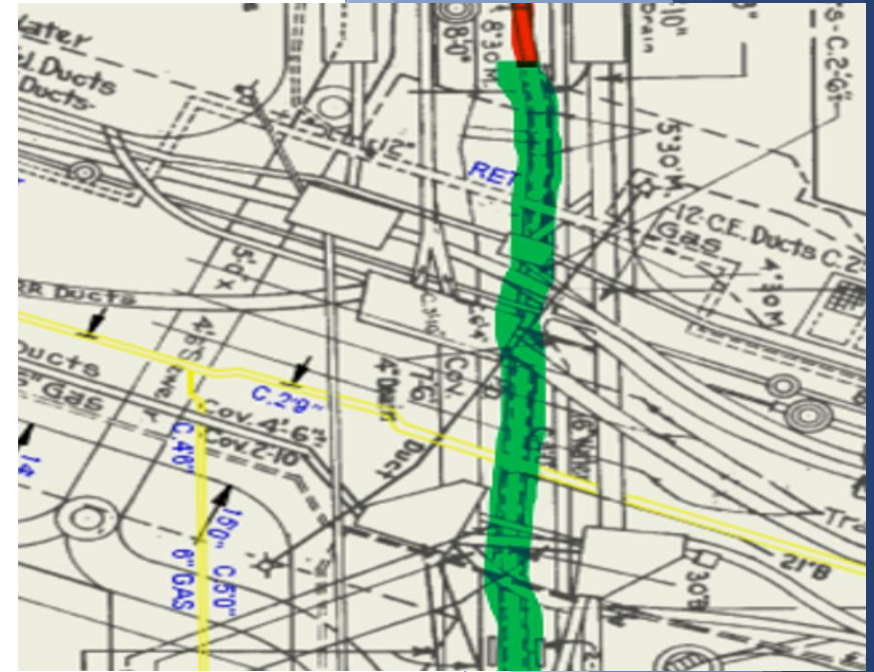
► Inspection of Cased Transmission Main

- ✓ 20" main inside 26" casing
- ✓ MTA Subway tunnel passing underneath and perpendicular to gas main
- ✓ High Traffic area of NYC
- ✓ Casing had 5+ changes of direction
- ✓ High Voltage power lines & transit fiber optics in close proximity of gas main
