HURRICANE IDA IMPACT & LESSONS LEARNED

PSE&G Gas Response and Restoration

Paul Pirro – PSE&G Gas T&D Engineering
April 20, 2022

2022 NGA Spring
Operations Conference

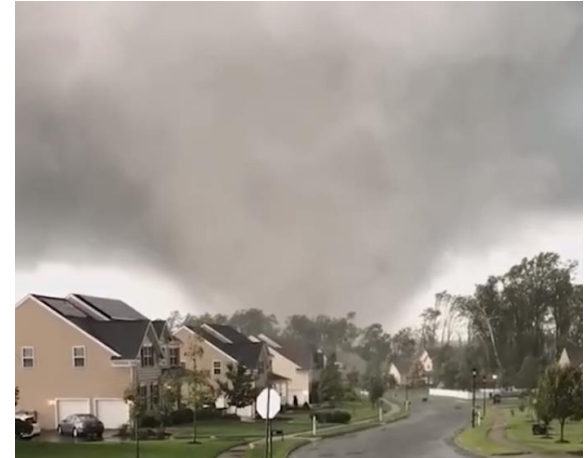
- Ida was the 3rd tropical system in a matter of weeks. Prior storms Fred and Henri left the soil saturated with a greater risk of flooding
- Approximately 35 municipalities were impacted by flooding
- Newark airport grounded all flights
- Multiple tornadoes were confirmed
- According to the CDC, Ida resulted in 34 deaths in New Jersey, making it one of the deadliest storms in its history

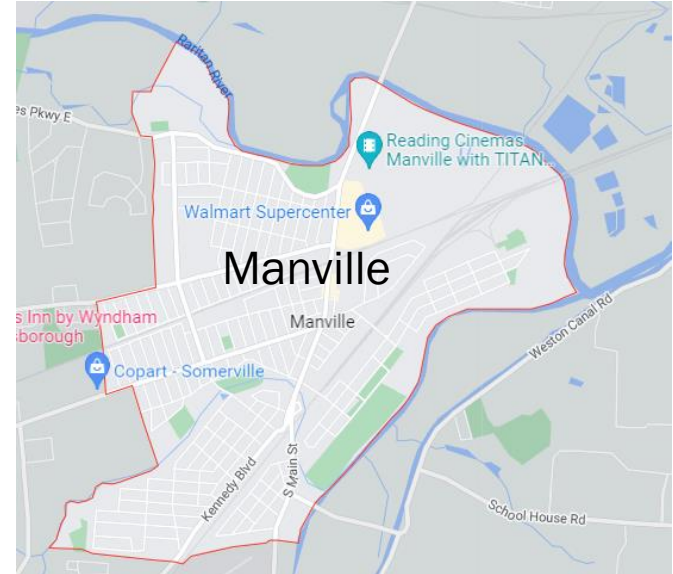
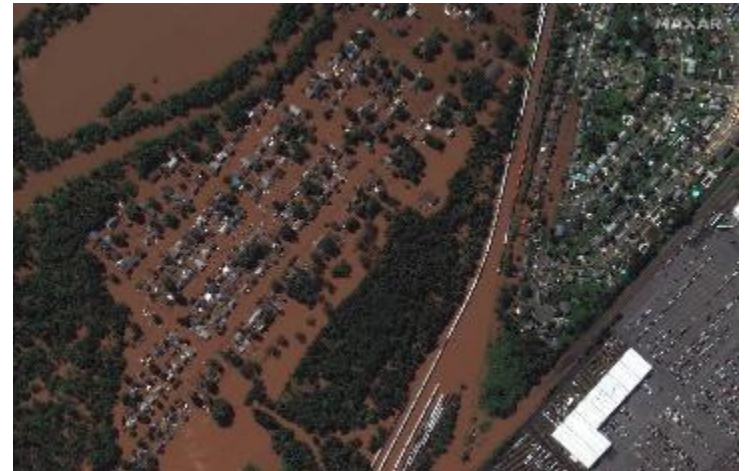
- Manville Borough experienced extreme flash floods due to heavy rainfall as well as the surging of nearby rivers
- PSE&G has approximately 3,700 gas customers and 45 miles of 35 psig MAOP gas main in Manville
- Approximately 2,380 gas customers in Manville experienced a gas service interruption or had an inspection due to flooding

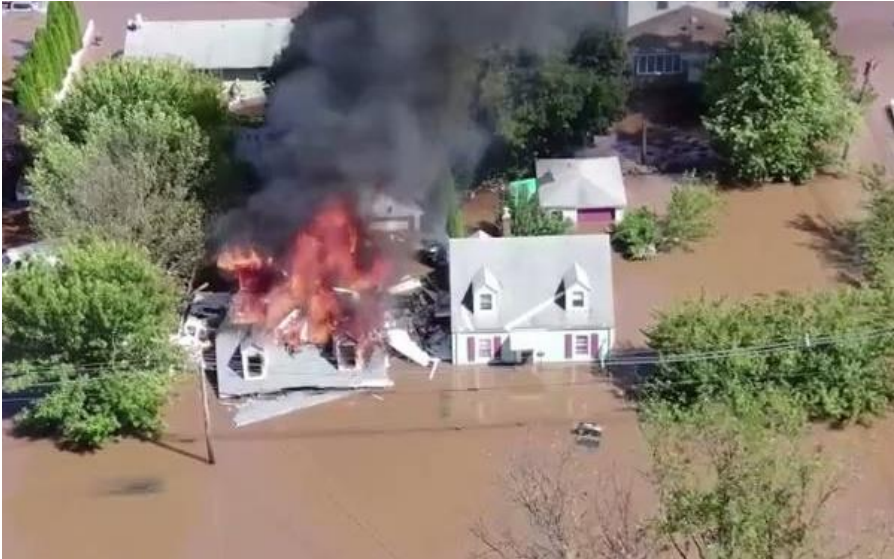
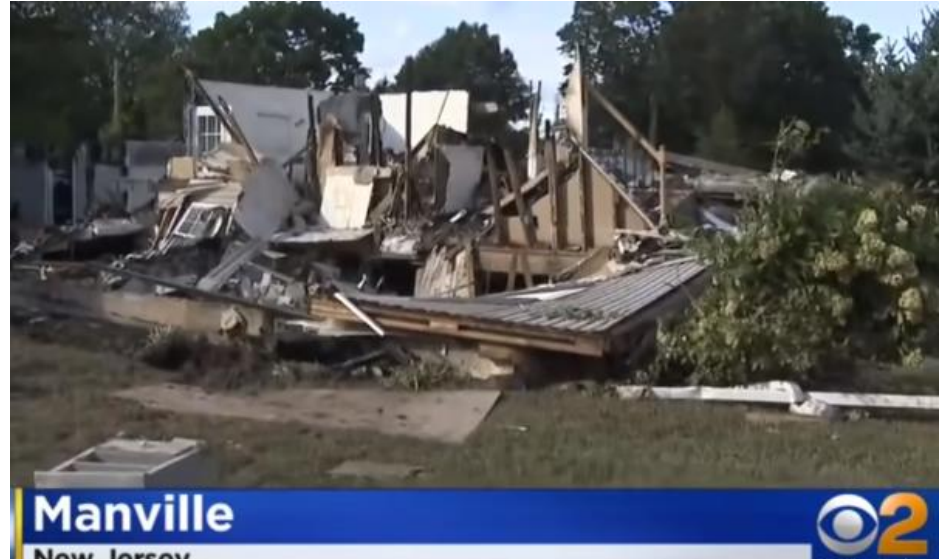
- There were five building fires and explosions in Manville overnight Sept 2nd into Sept 3rd
- Assistance from local Fire Departments was hindered by the flood waters

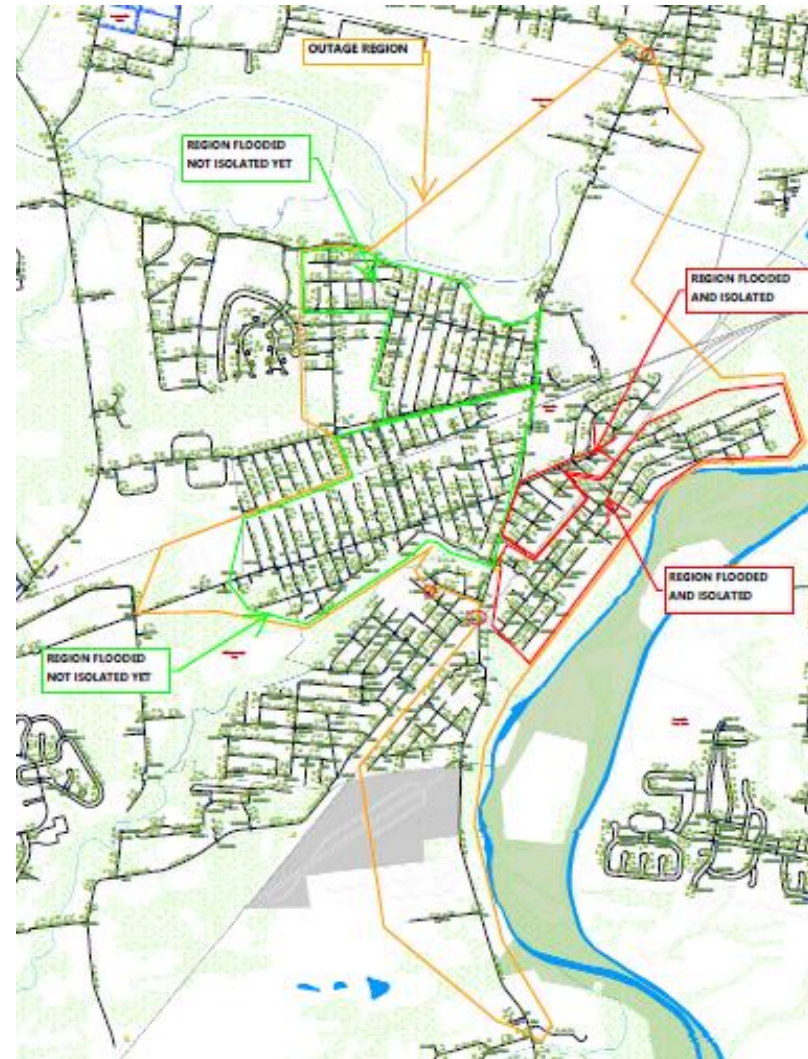
- With initial reports of explosions and fires, Engineering worked with Gas Operations to identify valves to isolate the area and reduce pressure
- Issues occurred due to flood waters still rising and valves becoming inaccessible
- Multiple iterations were required to locate accessible valves to isolate area (orange)
- After the final explosion on Sept 3rd, decision was made to attempt a full shutdown of area
- Larger valves may have had blow by as full shut down to 0 psig could not be achieved within the full area
- As water receded, personnel could reach valves to do a full shut down of Lost Valley area (red) and fully assess other flood impacted areas (green)

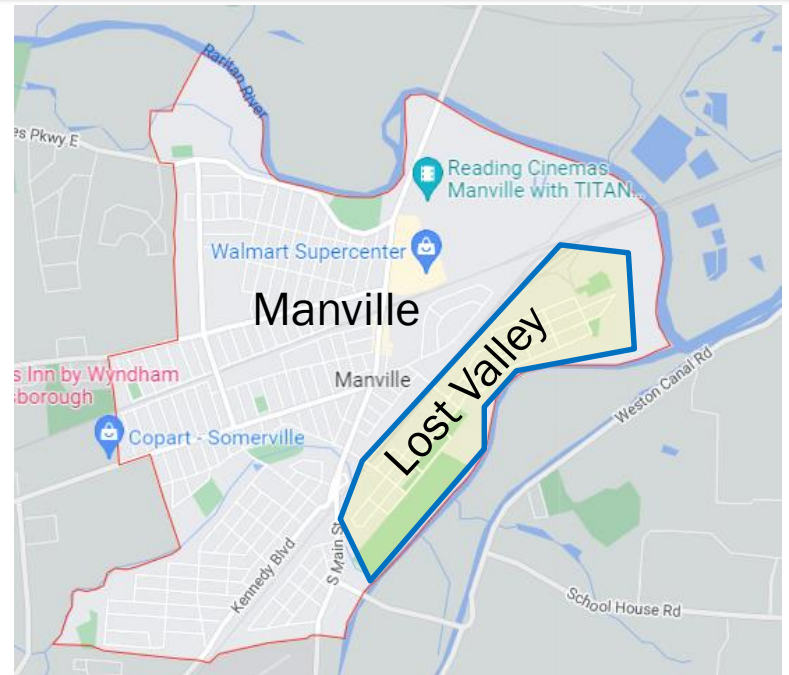
- Lost Valley in Manville is located on the natural flood plain between the Raritan and Millstone Rivers, which makes it prone to flooding
- Several major flooding events occurred during Hurricane Floyd, April 2007 Nor'easter, Hurricane Irene, as well as Ida
- The nearby Raritan River was flooded to a record 27.66 feet during Ida, breaking its previous record set by Hurricane Floyd (1999)
- Previous Army Corps studies were conducted to assess the feasibility of building a seawall along the Millstone and Raritan River Basin to combat future flooding

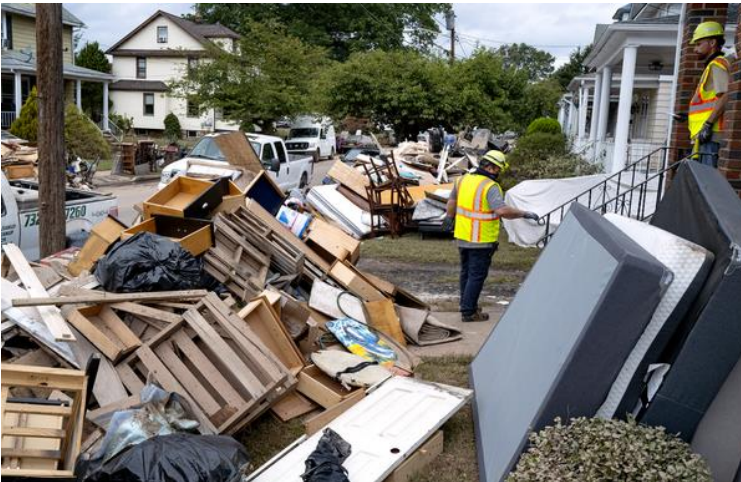
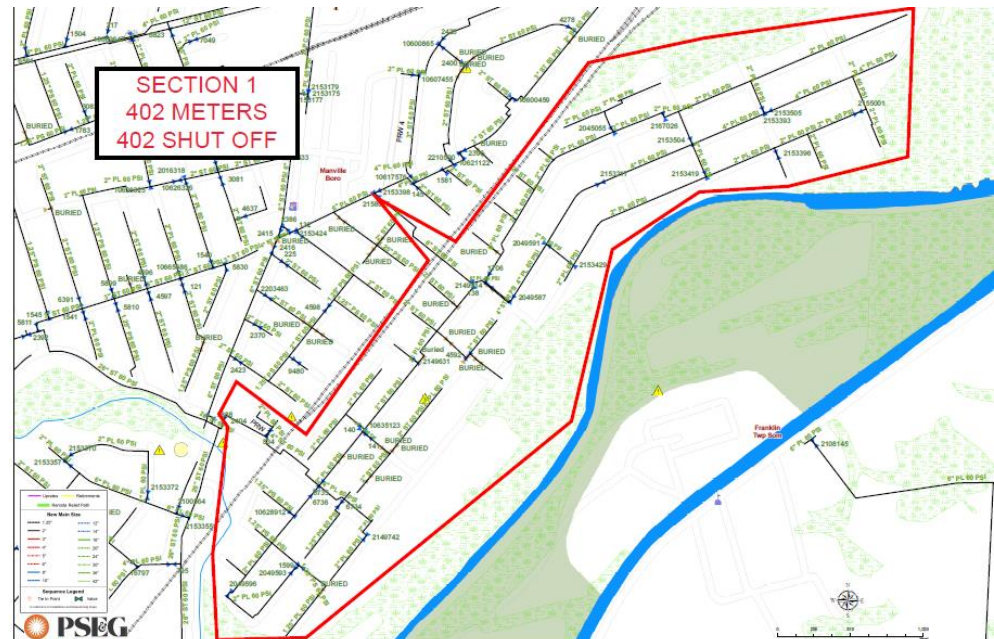
- With flood waters receding, the Lost Valley area (i.e. Zone 1) was able to be sectionalized from the rest of the impacted areas and fully shut down to 0 psig utilizing 2 valves
- The remainder of the impacted area outside of Lost Valley remained at a reduced pressure between 3.5 and 10 psig due to valve blow by and/or a feed not found in records search
- 402 meters off with shut down in Zone 1

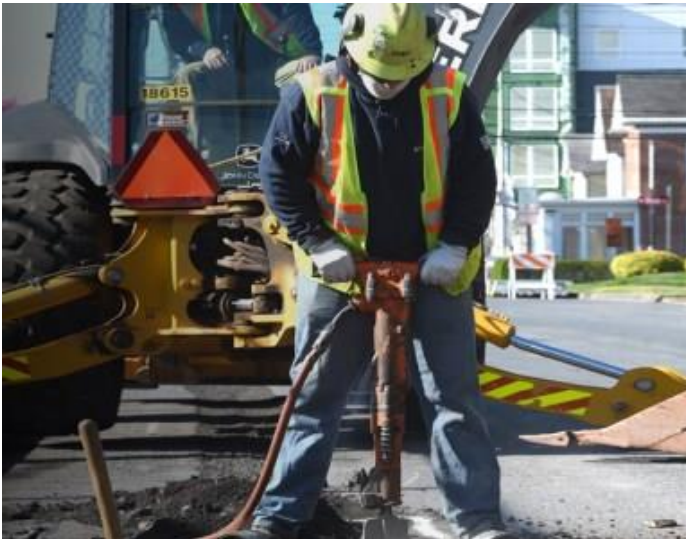
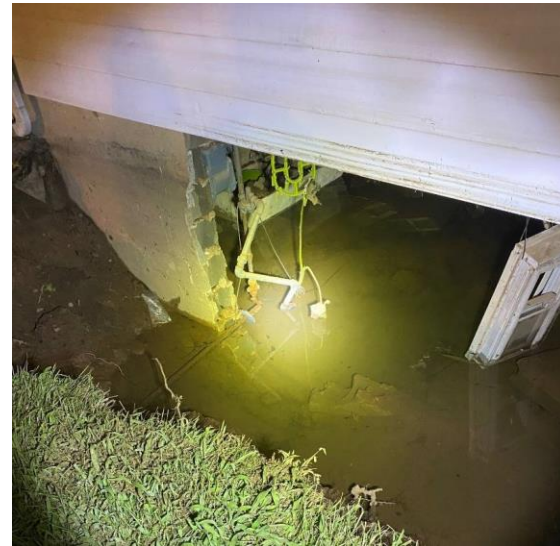
- Two locations excavated for camera inspection of the main prior to restoring gas pressure in Zone 1
- Concern over water/debris infiltration from compromised facilities (including damaged homes)
- Two locations at opposite ends of the isolation zone were chosen for excavation and plastic saddle installation on the main (would later be reused for gas re-introduction)
- All locations determined to be gas tight without infiltration

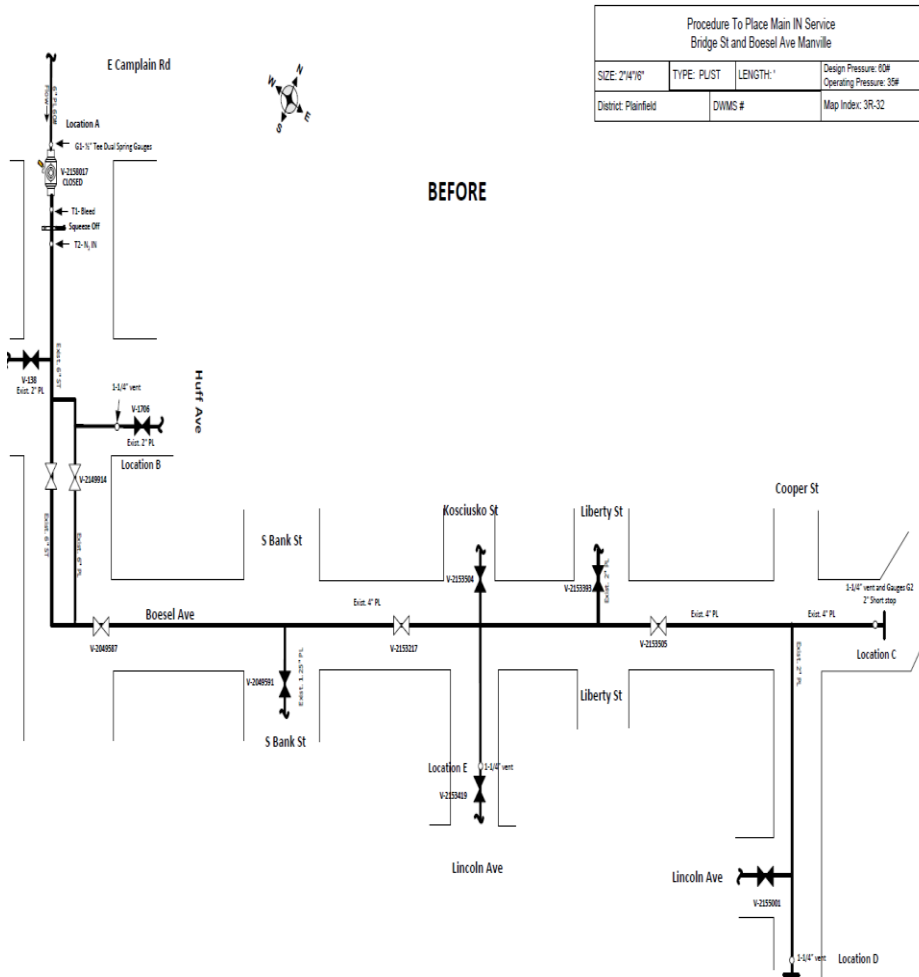
Inert Main Procedure for and Clear In Service Check List

Procedure To Place Main In Service Bridge St and Boesel Ave Manville			
SIZE: 2" x 1/8"	TYPE: PLUST	LENGTH: 1"	Design Pressure: 60# Operating Pressure: 35#
District: Plainfield	DWMS #	Map Index: 3R-32

Manville Restoration Sequence	
Zone Area: Zone 1 Section B	Design Pressure: 60 psi Operating Pressure: 35 psi

Step	Operation
	FOLLOW CLEAR INTO SERVICE CHECKLIST
1.	Ensure the following valves are open, if not open the valves 6735, 138, 140, 10635123, 2149631, 4592
2.	Install 3/4" vents at A, B, C, D, E, F, G, H, J, K Install 1 1/4" vent at I
3.	Slowly open valve 6735 to clear main into service venting at A, B, C and D until a reading of 95-100% gas is obtained
4.	Open valve 4592 to clear and vent at E and F until a reading of 95-100% gas is obtained.
5.	Open valve 141 to clear and vent at H and I until a reading of 95-100% gas is obtained.
6.	Open valve 10635123 to clear and vent at J and K until a reading of 95-100% gas is obtained.
7.	Close and remove vents
8.	Using Valve 6735, Bring pressure up in four equal increments (1 psig, 11 psig, 21 psig, full line pressure 35 psig), leak checking at each step. Fully open Valve 6735
9.	Valve 138, remains closed. Red tag.

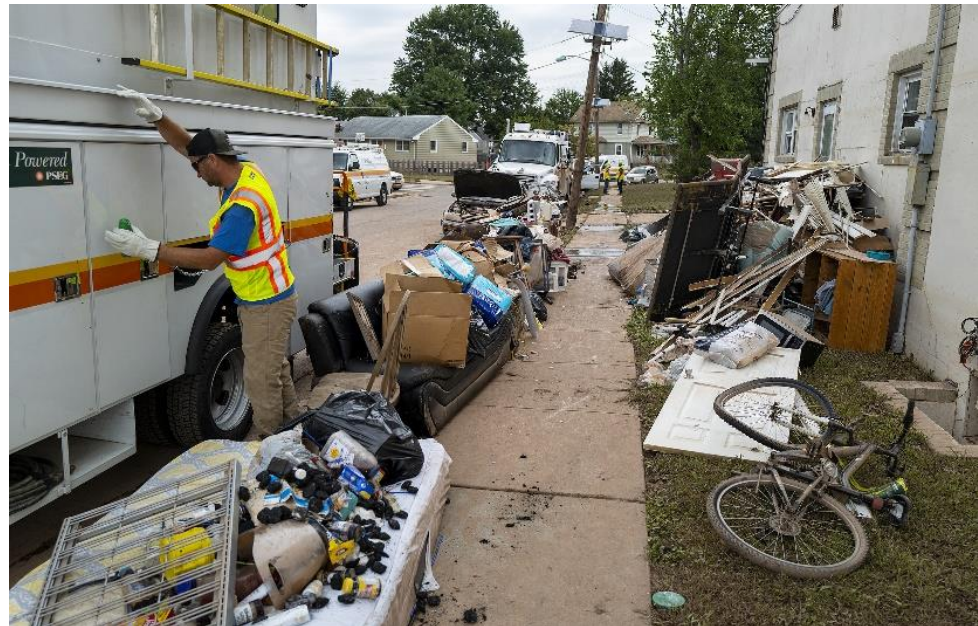
- Use a buffer beyond the scope of the procedure to verify adjacent homes/structures are not within the scope of the gas main procedures or are included and properly isolated
- Prepare vents and equipment needed and review procedures
- Calculate and obtain sufficient nitrogen tanks for the sections requiring inerts
- Set up rally points and communication structure to Incident Command ahead of procedure execution
