# Northeast Gas Association

2020 Virtual Gas Operations School

# Incident Investigation for the First Responder

Brad Thomas

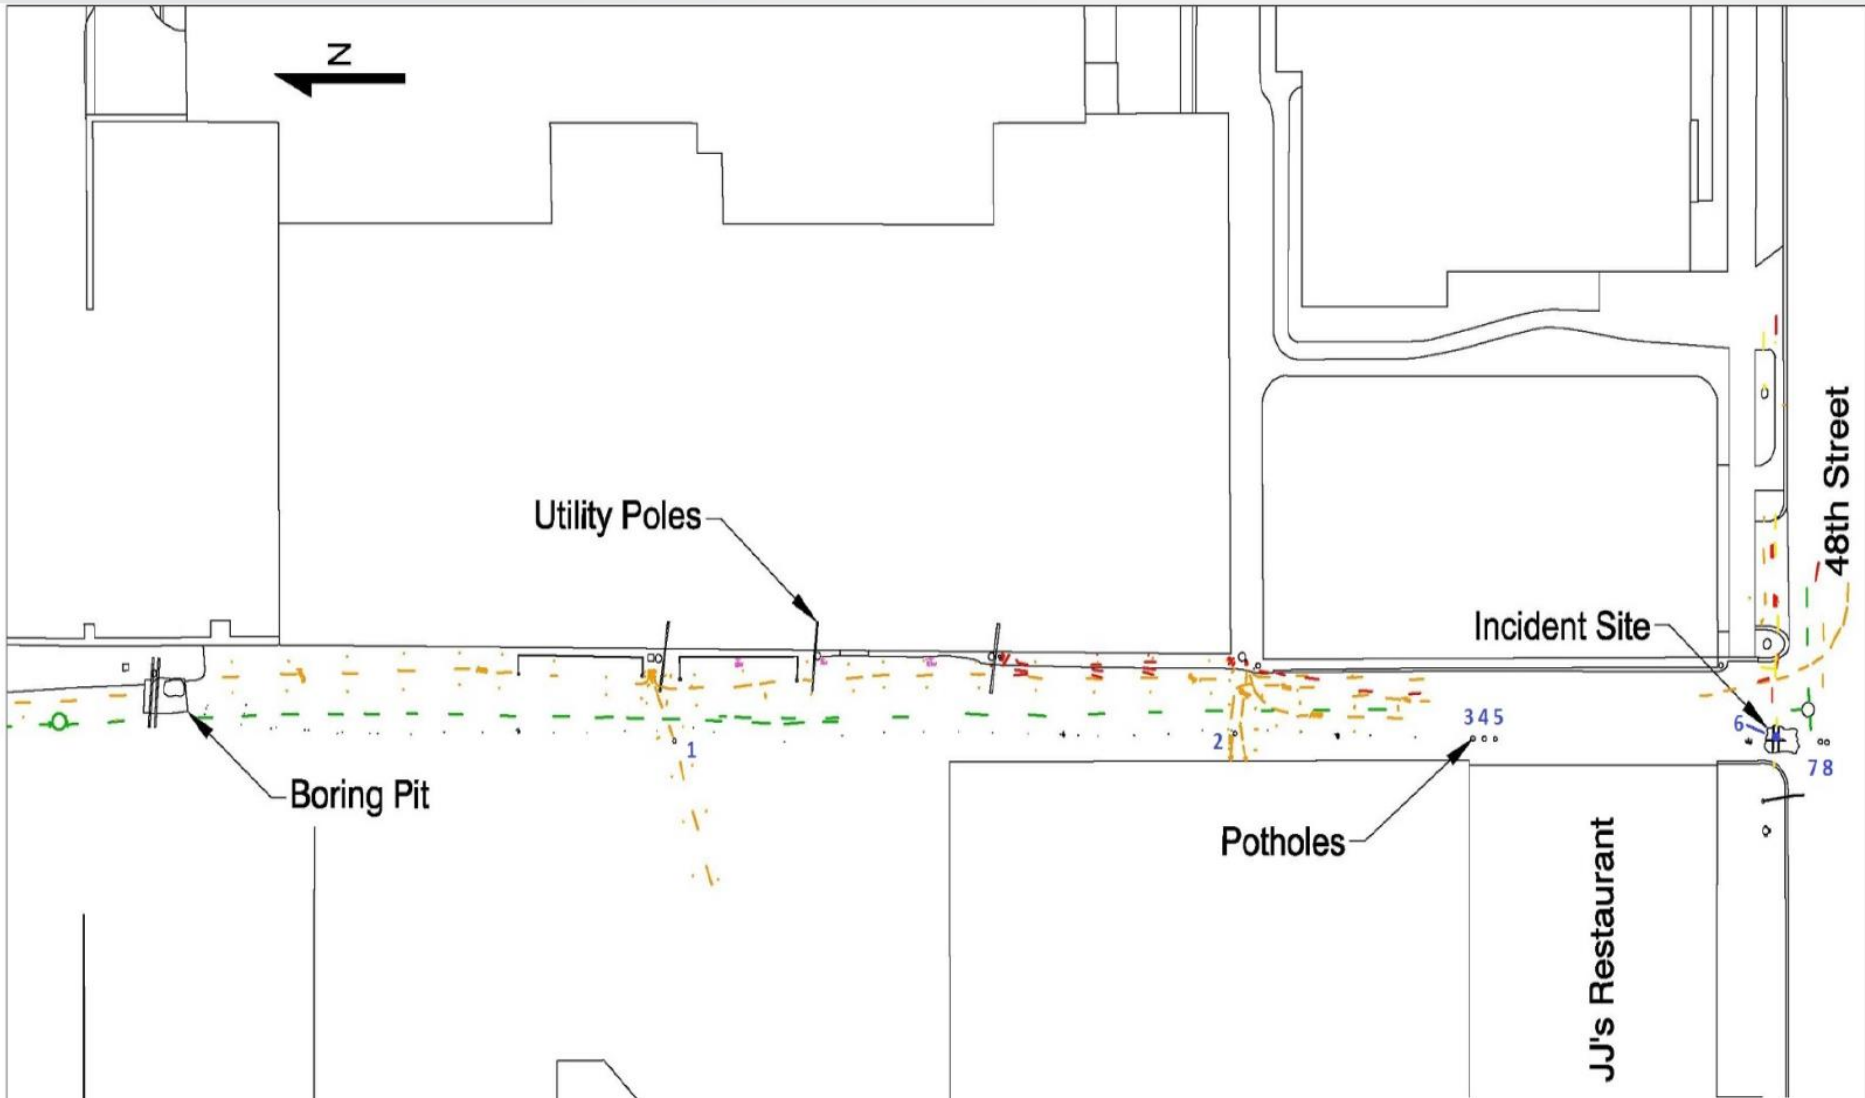
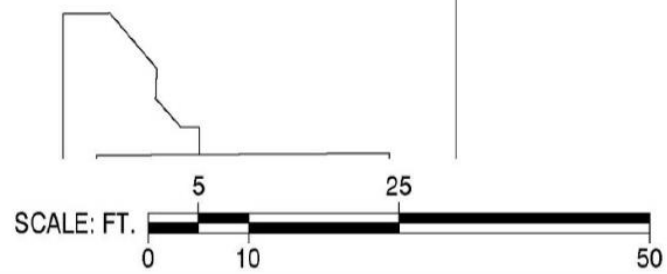
Site Drawing			
EXP/MGE/KANSAS CITY			
PROJECT NO.	FILE NAME		
B7948	SiteDrawing.dwg		
Inspection Date	VARIOUS	DR JT	PAGE 1 OF 1

- Gas company personnel and workers from two contractors were at the location of the damaged natural gas main at the time of the explosion.
- Several of these individuals received injuries as a result of the explosion and subsequent fire.
- The source of the gas that caused the explosion and fire was from a damaged 2" PE main operating at 25 psig.
- The cause of the damage was a horizontal drill being operated by a contractor installing a fibre optic line for the local phone company.

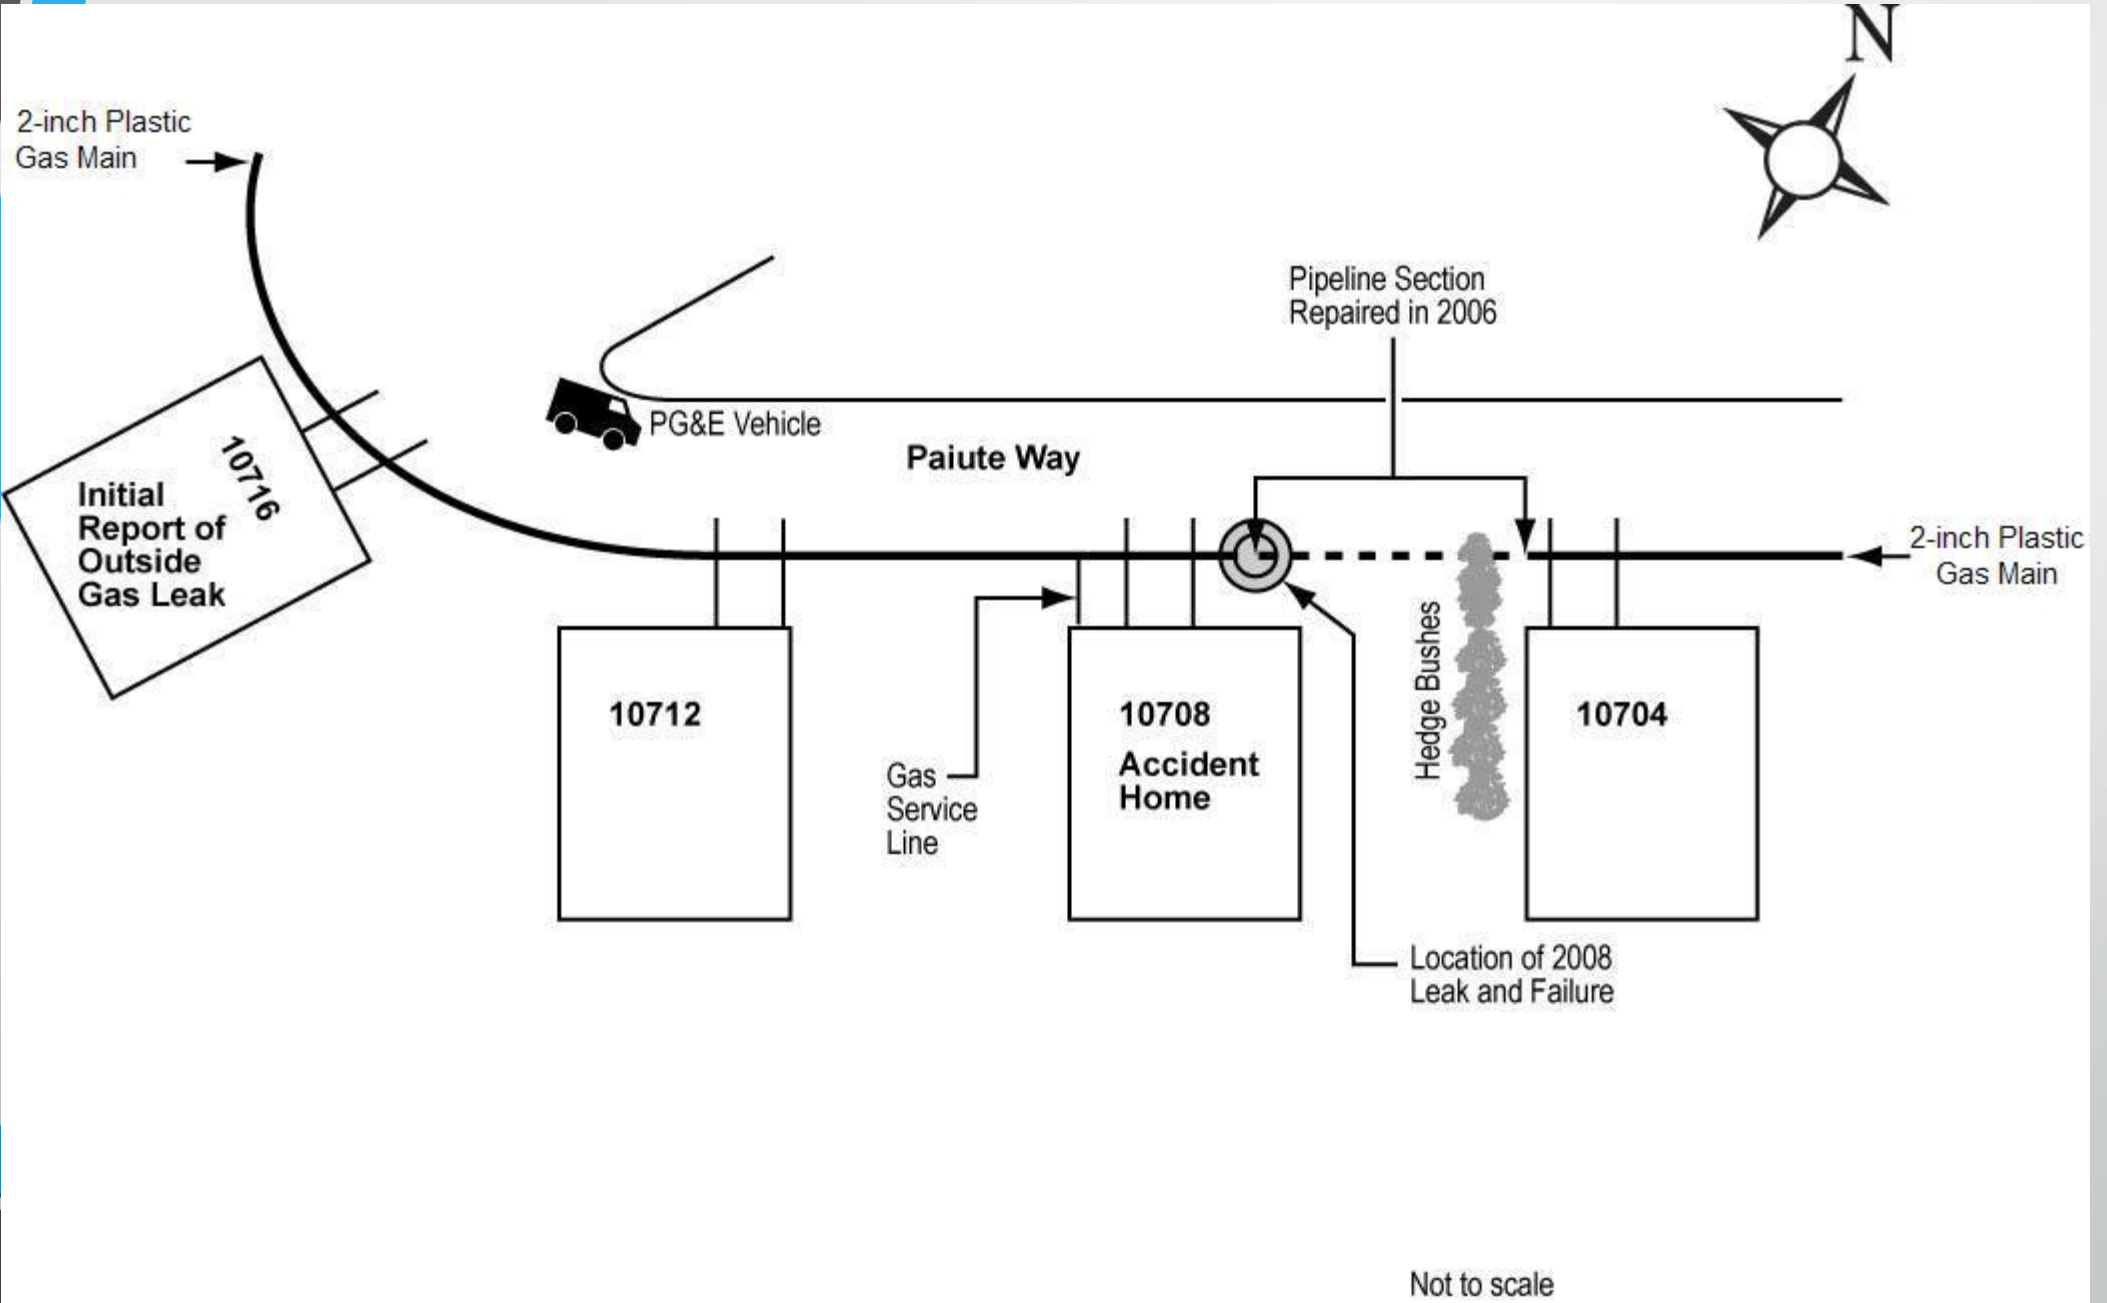
Location of 2008 Leak and Failure

- 10:42 – 11:11 AM The Technician determines there is a leak in front of 10708 Paiute Way approximately 5 feet west of the drive way and 45 feet in front of the house. The Technician knocks on the door in an attempt to gain access but there is no answer.
- 11:11 AM The Technician again contacts the call center to request assistance.
- 11:26 AM The Maintenance Department acknowledges the request for assistance at 10708 Paiute Way.
- 11:30 AM A Maintenance Department Leak Investigator arrives at the service center to pick up a Flame Ionization Leak Detector.

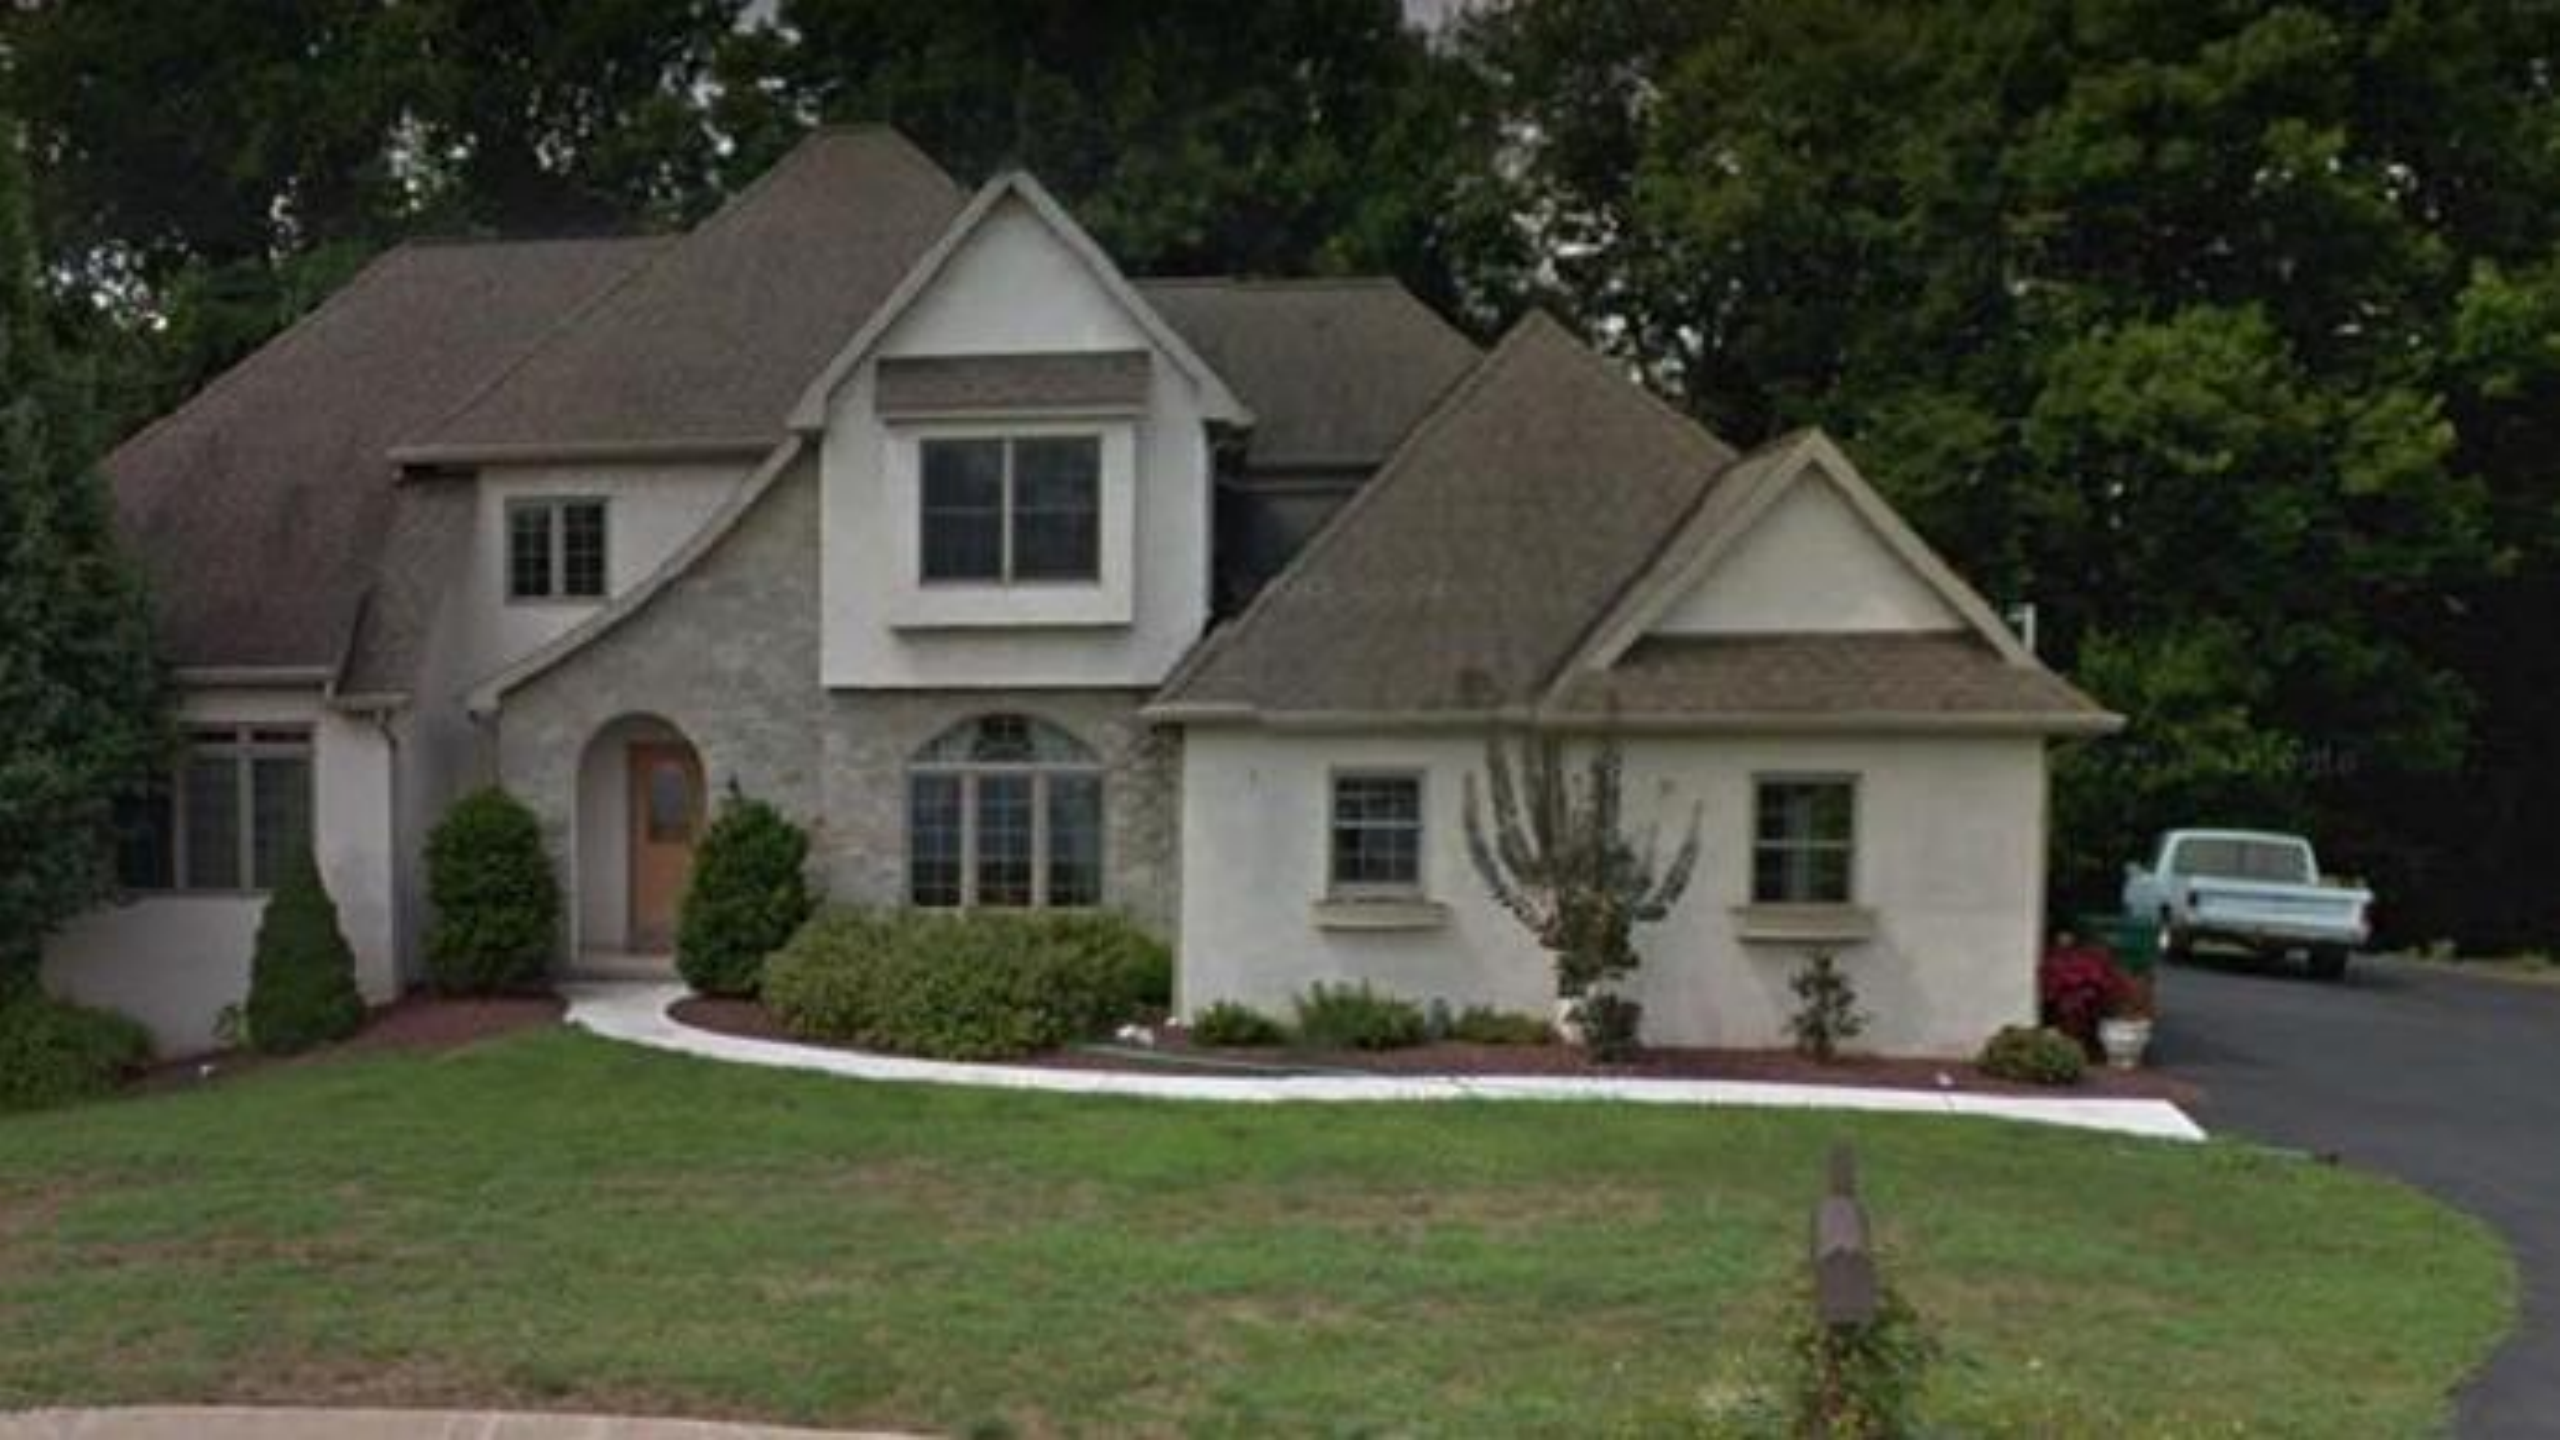
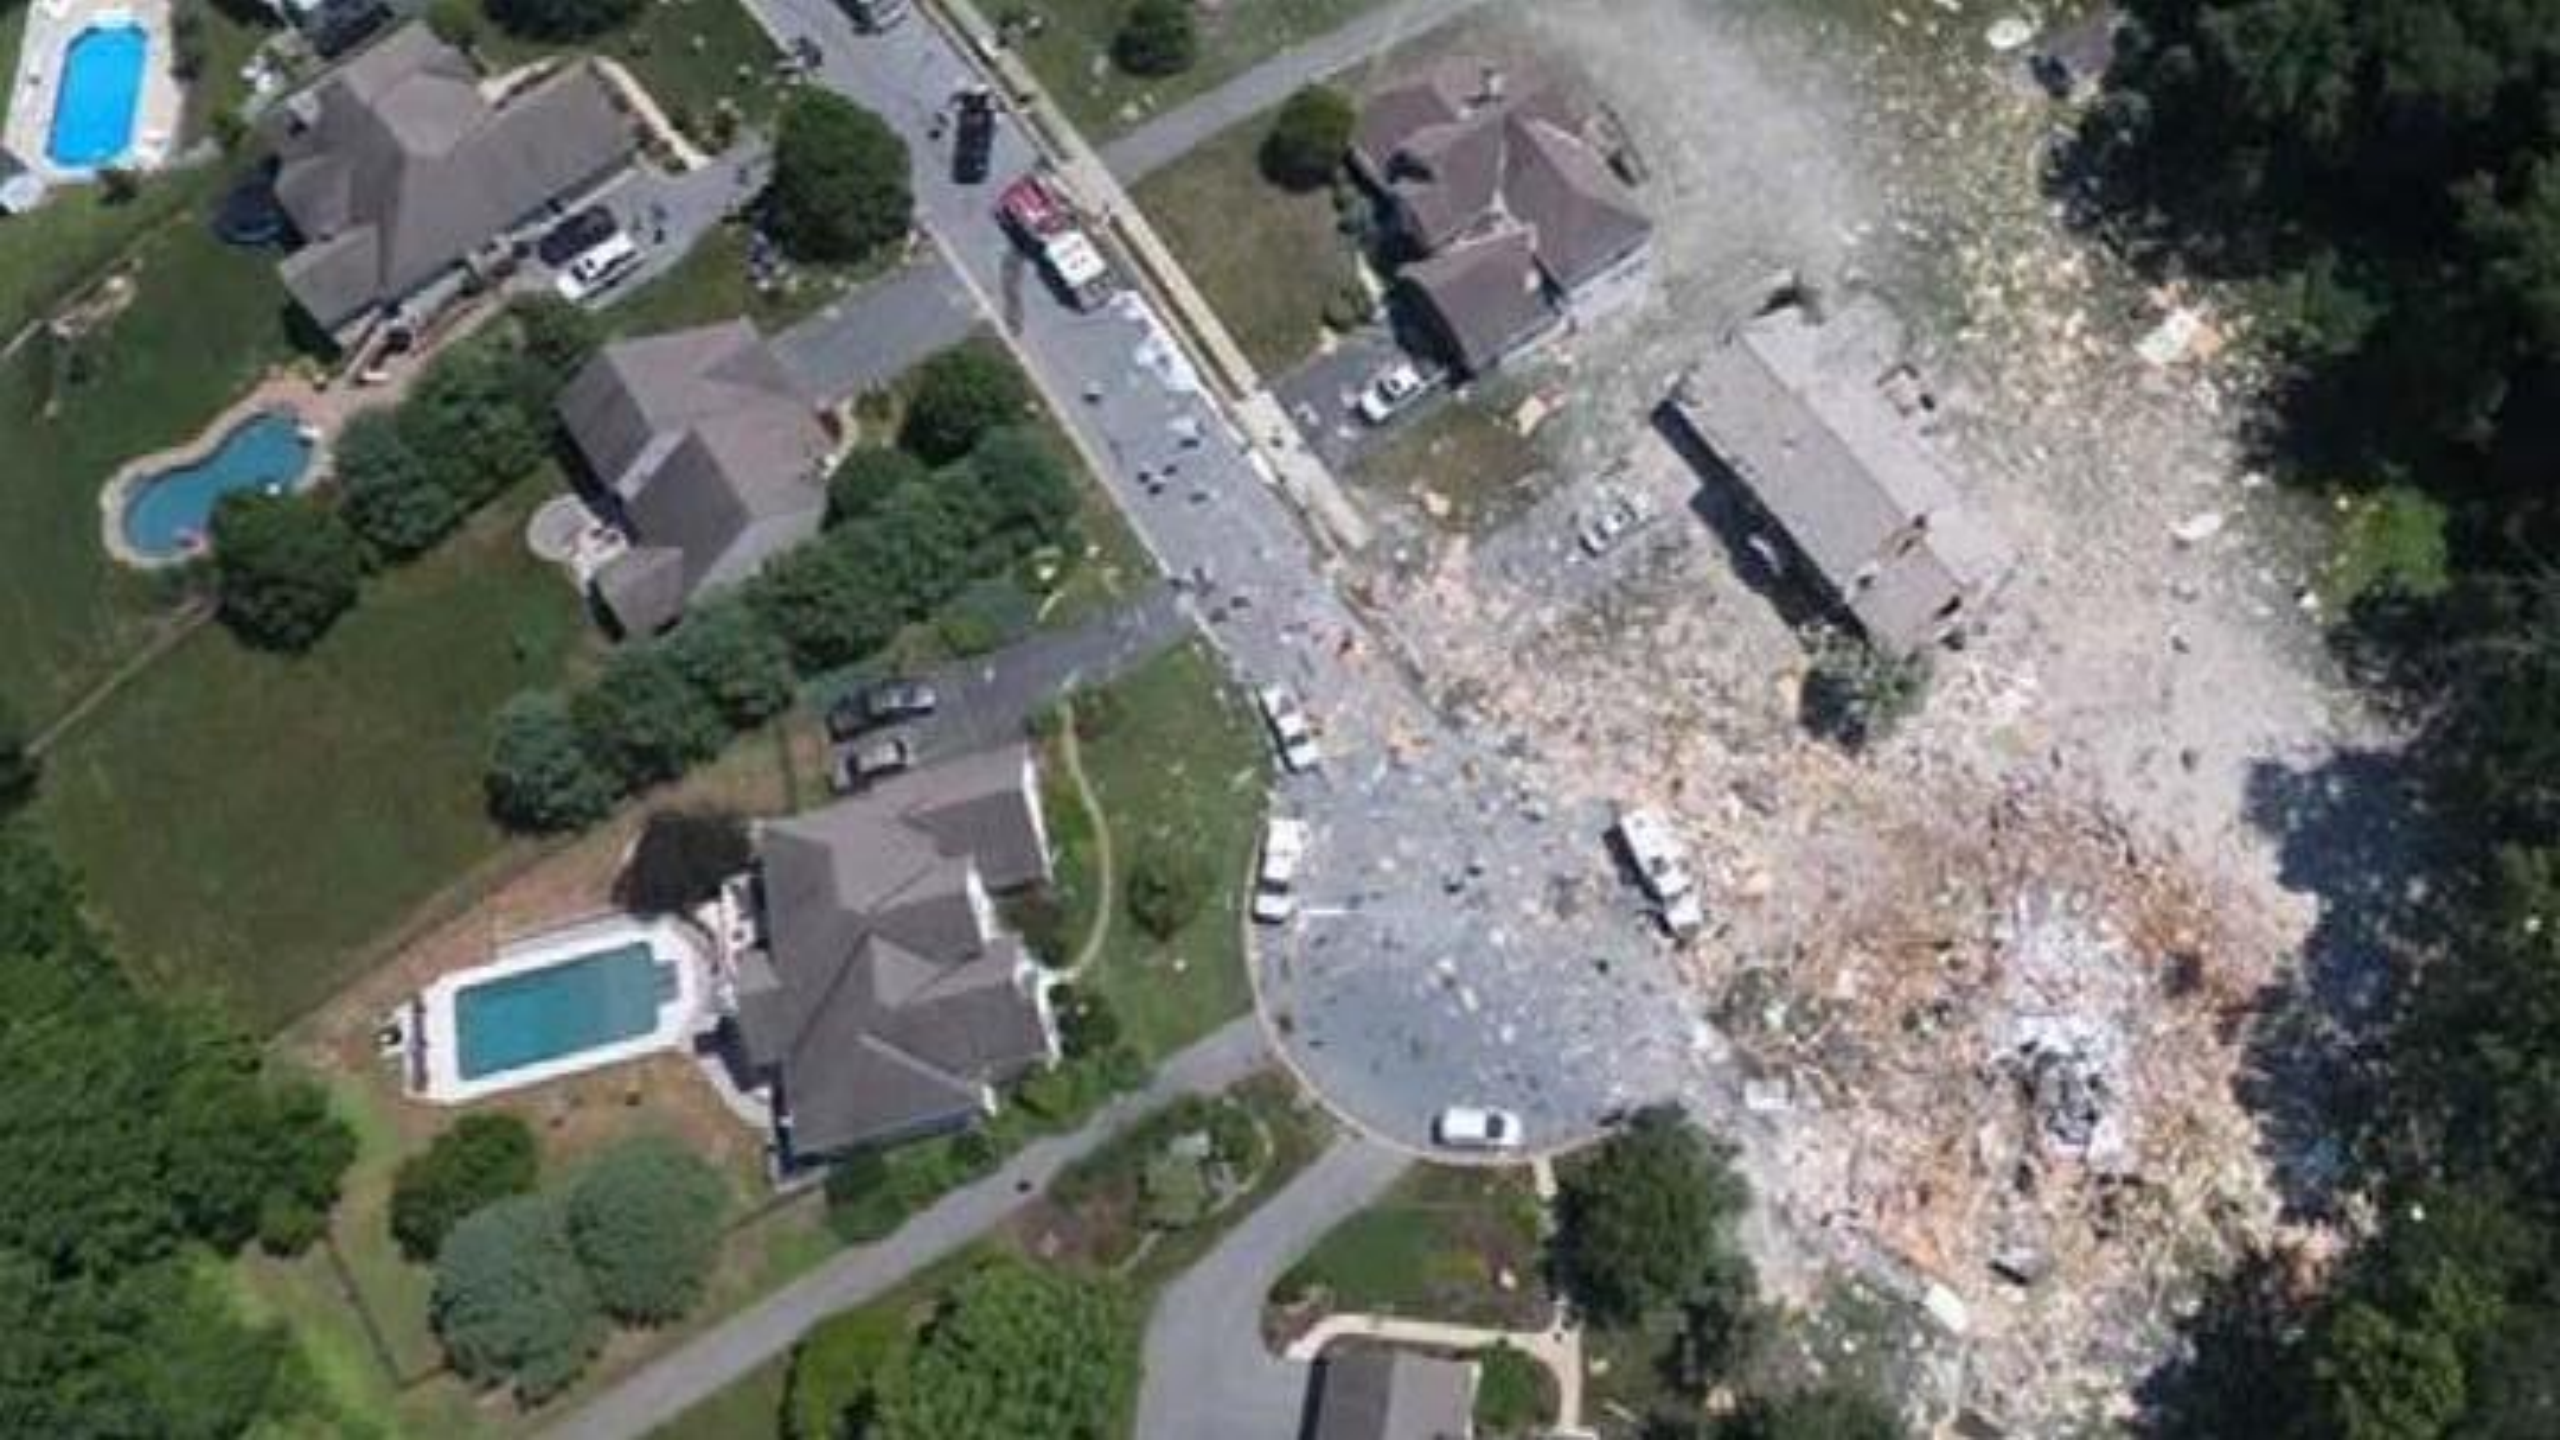
- On July 2, 2017, at 12:32 p.m. eastern daylight time, a natural gas fueled explosion occurred at a single-family residence at 206 Springdale Lane, Millersville, PA.
- The explosion killed one person and injures three others.
- 206 Springdale Lane was destroyed, six neighboring homes were also damaged, one was condemned and had to be torn down.

- The National Transportation Safety Board determines that the probable cause of the natural gas explosion at 206 Springdale Lane was in improperly installed mechanical tapping tee that leaked and allowed gas to migrate into the house where it ignited.

- Pipeline Facility Improvements
  - Ongoing project to identify and repair or replace mechanical tees through the distribution system
  - As of October 2018, 2,577 mechanical tees have been remediated or replaced
- Dispatch Improvements
  - The operator modified their dispatch process or proactively identify the need for electrical shutdown and additional help
